Manhole Inspection Summary

Manhole # S29MM_030MH

Insp Date: **7/17/07 10:00 AM**

Location Address: **2000 PARK AVE**

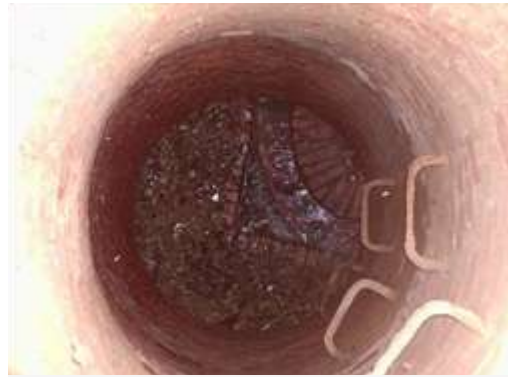
Top View

Corroded steps. Bench debris.

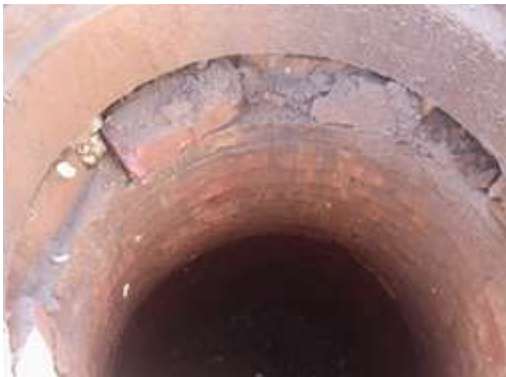
Defect

Frame leaks. Frame offset. Adjustment deterioration, loose brick and infiltration. Barrel infiltration.

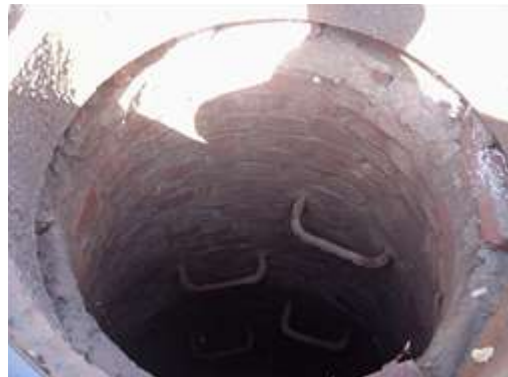
Defect

Frame leaks. Adjustment deterioration and infiltration. Barrel infiltration.

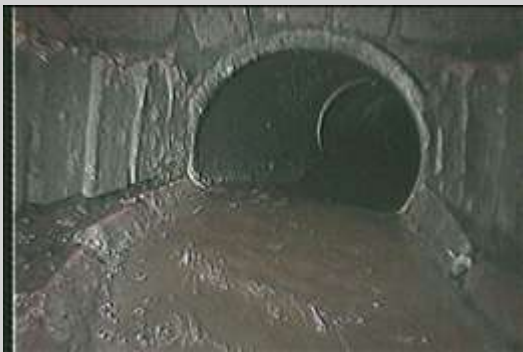
8 in. Circular Gravity Sewer Pipe Out @ 12 O'Clock

Channel deterioration.
